## LOCAL HISTORIC PROPERTY DESIGNATION REPORT

**historic name** Buena Vista Heights Historic District  
**other names/site number**

**street & number** The Buena Vista Heights Historic District is an area of approximately eight square blocks located west of the Boulevard Historic District in Athens, Georgia.  
The area is roughly bounded by the front property lines of parcels along the western side of Park Avenue and the western side of Satula Avenue (East); the rear property lines of parcels along the northern side of Nantahala Extension and the front property lines of parcels on the southern side of Boulevard (North); the rear property lines of parcels on the western side of Buena Vista Avenue and the front property lines of parcels on the eastern side of Pound Street (West); by the northern rear property lines of properties at the northern side of Prince Avenue (South). For precise boundaries, SEE ATTACHED HISTORIC DISTRICT MAP (Page 6).

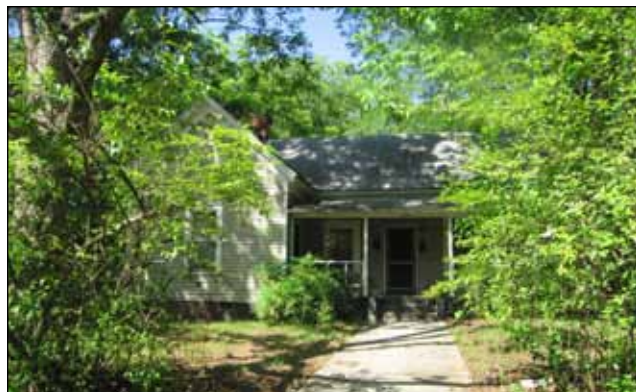
### **470 Yonah Ave. / Tax parcel #11-4-C2-D010**

- › c. 1925
- › Gabled ell cottage house type
- › This building was constructed within the period of significance for the district and retains historic integrity. Therefore, it is a contributing resource.
- › Alterations include duplex use, multiple rear additions (nonhistoric) and replacement windows.

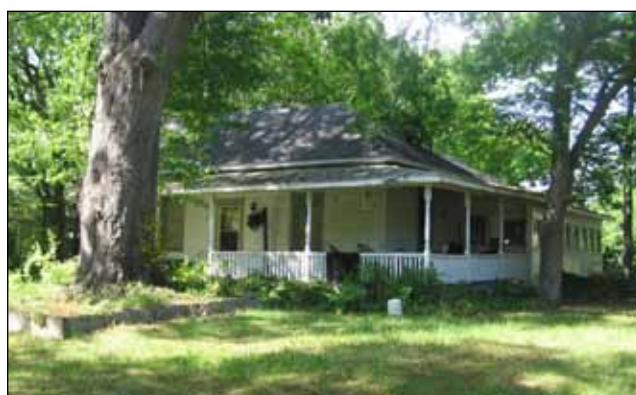
#### **Contributing**

- › c. 1915
- › Central hallway house type
- › This building was constructed within the period of significance for the district and retains historic integrity. Therefore, it is a contributing resource.
- › Alterations include multiple rear and side additions, including historic additions.

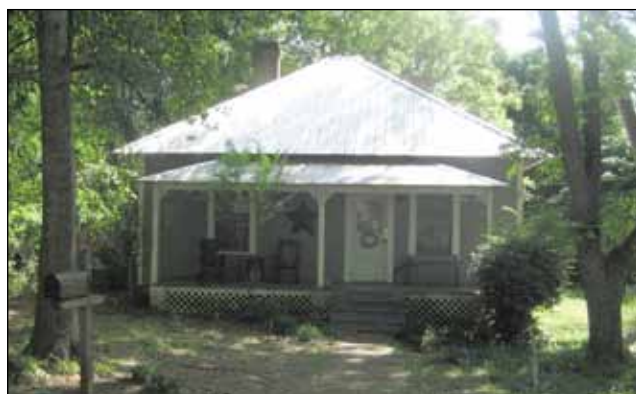
### **469 Yonah Ave. / Tax parcel #11-4-C2-C006**

#### **Contributing**

- › c. 1910
- › Hip-roofed bungalow house type
- › This building was constructed within the period of significance for the district and retains historic integrity. Therefore, it is a contributing resource.
- › Alterations include a rear porch addition

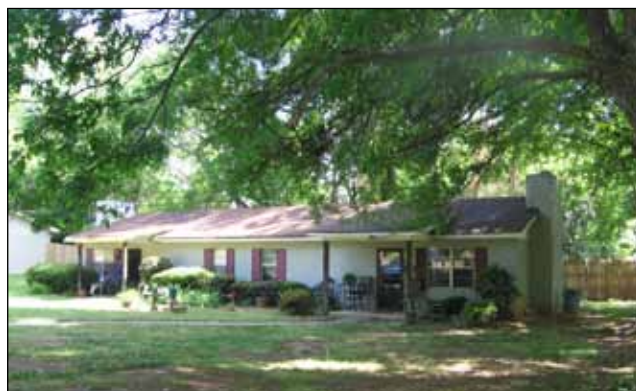
### **445/447 Yonah Ave. / Tax parcel #11-4-C2-C005**

#### **Noncontributing**

- › c. 1975
- › Ranch style duplex house type
- › This building was constructed after the period of significance for the district. Therefore, it is not a contributing resource.

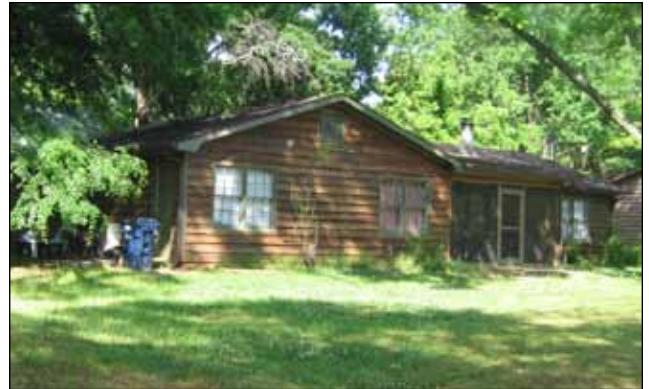
**440/442 Yonah Ave. / Tax parcel #11-4-C2-D001A**

**Noncontributing**

- › c. 1975
- › Ranch style duplex house type
- › This building was constructed after the period of significance for the district. Therefore, it is not a contributing resource.

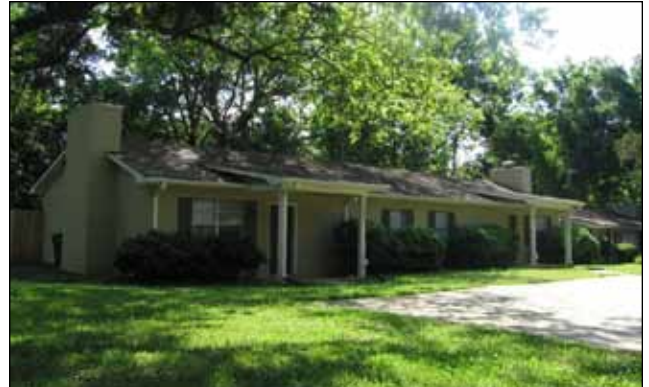
**425/427 Yonah Ave. / Tax parcel #11-4-C2-C005A**

**Noncontributing**

- › c. 1975
- › Ranch style duplex house type
- › This building was constructed after the period of significance for the district. Therefore, it is not a contributing resource.

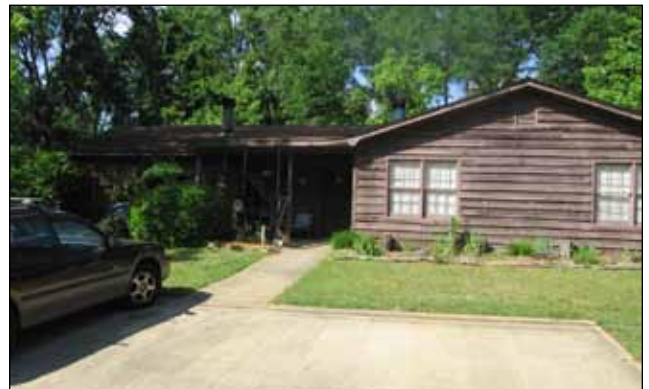
**420/422 Yonah Ave. / Tax parcel #11-4-C2-D001**

**Noncontributing**

- › c. 1975
- › Ranch style duplex house type
- › This building was constructed after the period of significance for the district. Therefore, it is not a contributing resource.

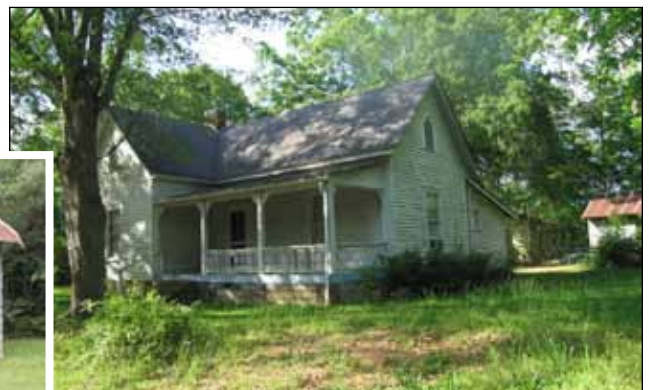
**375 Yonah Ave. / Tax parcel # 11-4-C4-A006**

- › c. 1915
- › Gabled ell cottage house type
- › This building was constructed within the period of significance for the district and retains historic integrity. Therefore, it is a contributing resource.
- › Alterations include a historic shed behind the house (inset photo) and a rear addition.

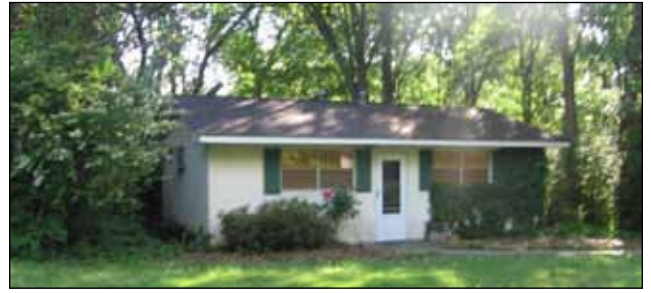
**Noncontributing**

- › c. 1970
- › Ranch house type
- › This building was constructed after the period of significance for the district. Therefore, it is not a contributing resource. *\*Note that while it is a different address, it is on the same parcel as 190 Boulevard Heights.*

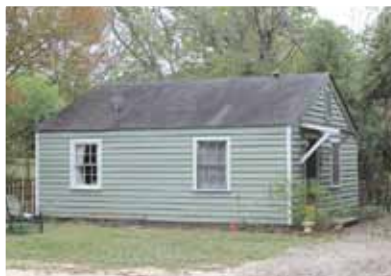
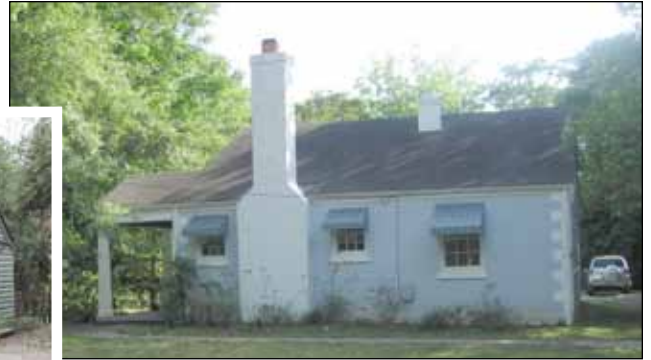
**355 and 355 1/2 Yonah Ave. / Tax parcel #11-4-C4-A005**

**Contributing**

- › c. 1950
- › Side-gabled bungalow house type
- › This building was constructed within the period of significance for the district and retains historic integrity. Therefore, it is a contributing resource.
- › Alterations include square pier porch supports, aluminum awnings and a painted brick exterior.
- › Historic front-gabled bungalow behind house c. 1945.

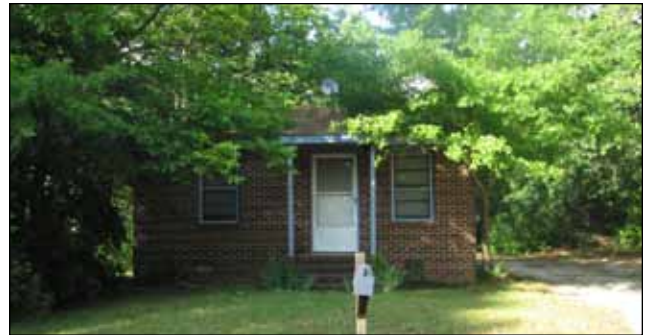
**350 Yonah Ave. / Tax parcel # 11-4-C2-E002**

**Contributing**

- › c. 1959
- › Side-gabled bungalow house type
- › This building was constructed within the period of significance for the district and retains historic integrity. Therefore, it is a contributing resource.
- › Alterations include replacement windows

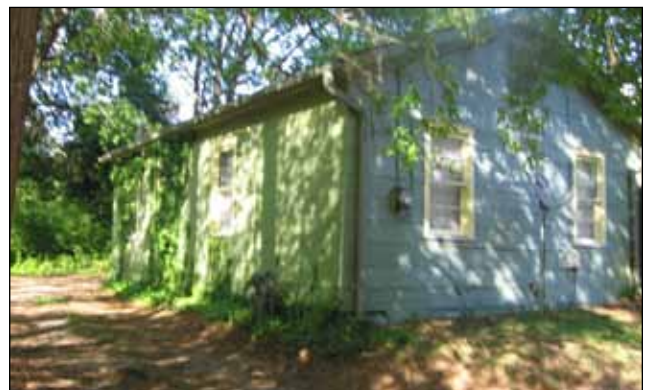
**362 Yonah Ave. / Tax parcel # 11-4-C2-E002**

**Contributing**

- › c. 1945
- › Side-gabled bungalow house type
- › This building was constructed within the period of significance for the district and retains historic integrity. Therefore, it is a contributing resource.
- › Alterations include fence obscuring facade

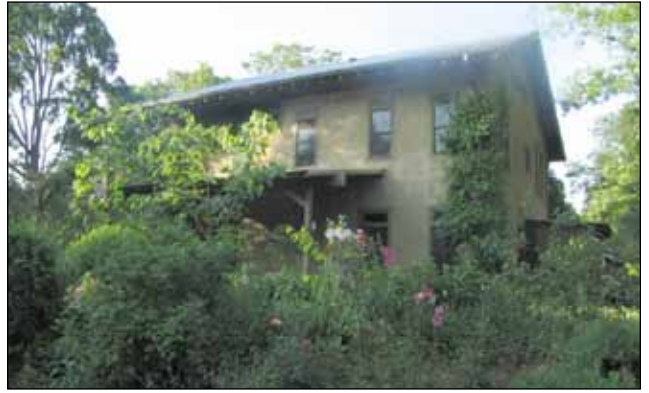
### **270 Yonah Ave. / Tax parcel # 11-4-C4-C005A**

#### **Noncontributing**

- › c. 2006
- › This building was constructed after the period of significance for the district. Therefore, it is not a contributing resource.

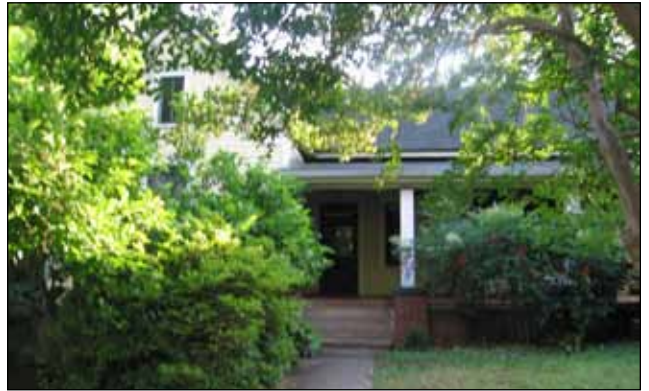
### **250 Yonah Ave. / Tax parcel # 11-4-C4-C006**

- › c. 1915
- › Gabled ell cottage house type
- › This building was constructed within the period of significance for the district and retains historic integrity. Therefore, it is a contributing resource.
- › Rear garage is also historic, built c. 1920.
- › Alterations include brick and wooden pier porch supports and replacement windows.

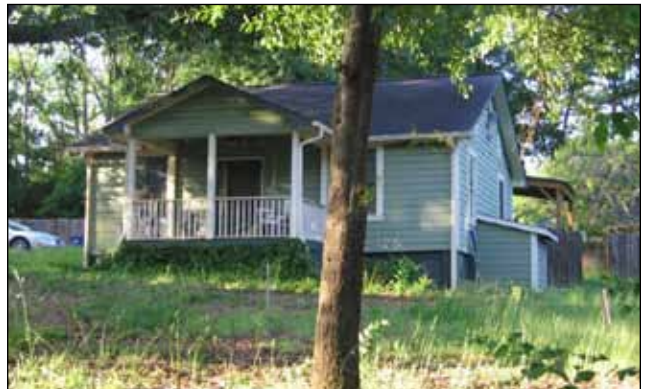
#### **Contributing**

- › c. 1940
- › Side-gabled bungalow house type
- › This building was constructed within the period of significance for the district and retains historic integrity. Therefore, it is a contributing resource.
- › Alterations include multiple rear and side additions.

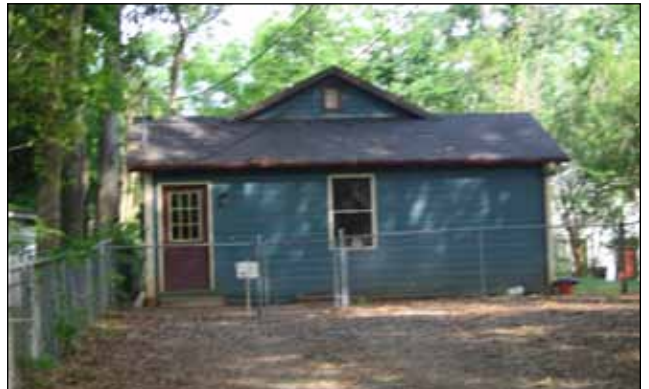
### **246 Yonah Ave. / Tax parcel # 11-4-C4-C006A**

#### **Contributing**

- › c. 1940
- › Bungalow house type
- › This building was constructed within the period of significance for the district and retains historic integrity. Therefore, it is a contributing resource.
- › Alterations include a vent in the roof gable.

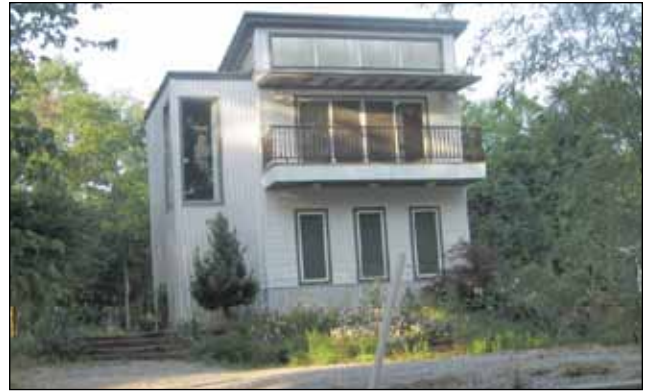
**238 Yonah Ave. / Tax parcel # 11-4-C4-C006B**

**Noncontributing**

- › c. 2005
- › This building was constructed after the period of significance for the district and therefore is not a contributing resource.

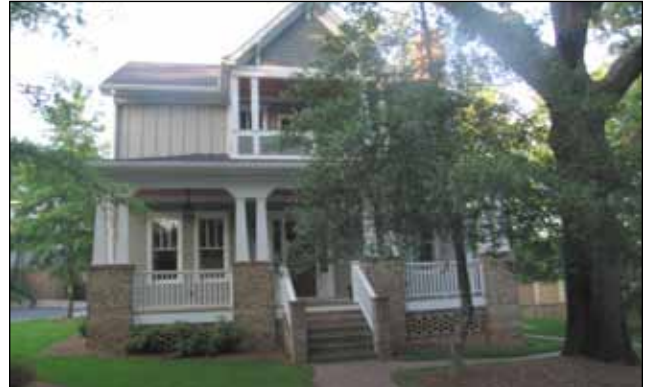
**230 Yonah Ave. / Tax parcel # 11-4-C4-C008**

**Noncontributing**

- › c. 2007
- › This building was constructed after the period of significance for the district and therefore is not a contributing resource.

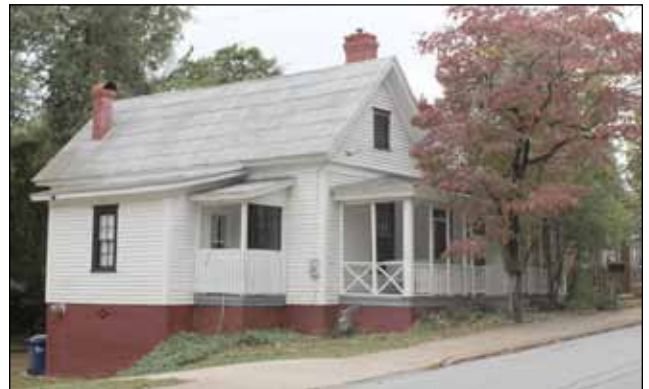
**160 Satula Ave. / Tax parcel # 11-4-C4-D004**

**Contributing**

- › c. 1900
- › Queen Anne cottage
- › This building was constructed within the period of significance for the district and retains historic integrity. It therefore is a contributing resource.
- › There are no significant alterations to the property.

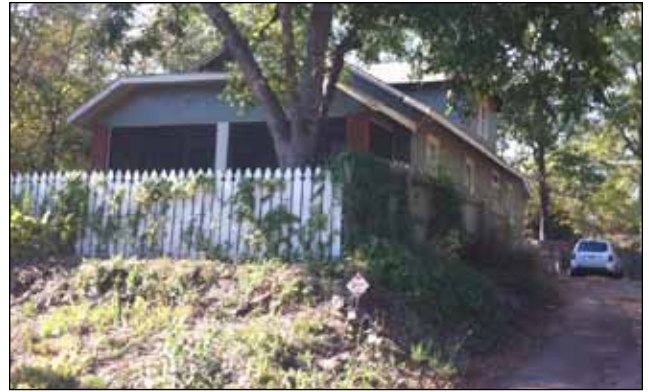
**165 Satula Ave. / Tax parcel # 11-4-C4-B008**

**Contributing**

- › c. 1920
- › Front-gabled bungalow
- › This building was constructed within the period of significance for the district and retains historic integrity. Therefore, it is a contributing resource.
- › Alterations include a front porch that has been enclosed, additional floor added at attic, multiple window types and sizes.
- › There is a noncontributing accessory structure in the side yard.

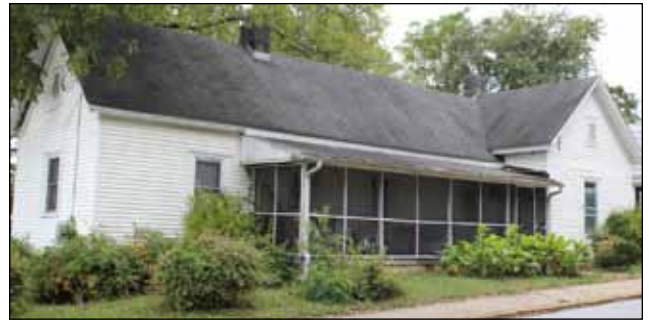
**190 Satula Ave. / Tax parcel # 11-4-C4-D003**

**Contributing**

- › c. 1915
- › Gabled ell cottage
- › This building was constructed within the period of significance for the district and retains historic integrity. Therefore, it is a contributing resource.
- › Alterations include an addition to left side of house, screened-in porch and nonhistoric shed additions.

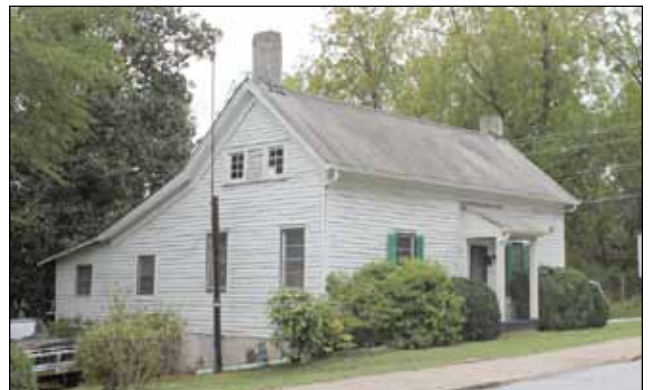
**235 Satula Ave. / Tax parcel # 11-4-C4-C009**

- › c. 1935
- › Central hallway house type
- › This building was constructed within the period of significance for the district and retains historic integrity. Therefore, it is a contributing resource.
- › Alterations include a box-shaped rear shed addition and altered front porch.

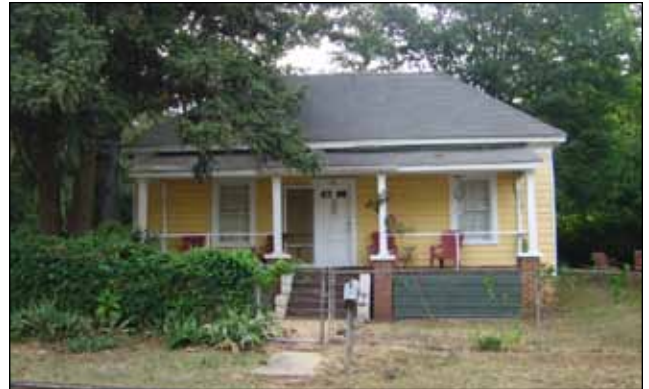
**Contributing**

- › c. 1918
- › Central hallway house type
- › This building was constructed within the period of significance for the district and retains historic integrity. Therefore, it is a contributing resource.
- › Alterations include replacement windows, multiple rear additions.

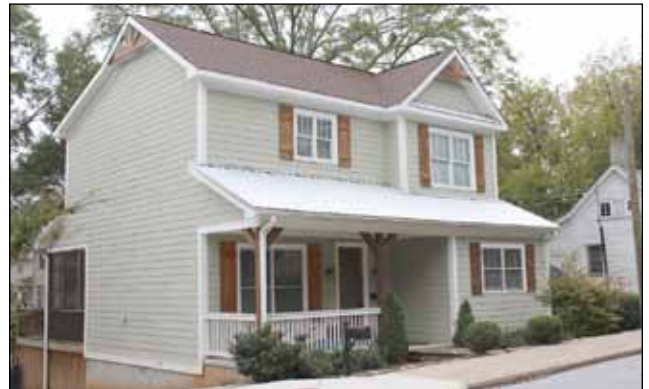
**250 Satula Ave. / Tax parcel # 11-4-D3-F013**

**Noncontributing**

- › c. 2009
- › Infill/new construction
- › This building was constructed after the period of significance for the district and therefore is not a contributing resource. Note that the property is listed in tax files as c. 1935, but as the result of construction in 2009, one remaining wall was converted into current two-story structure.

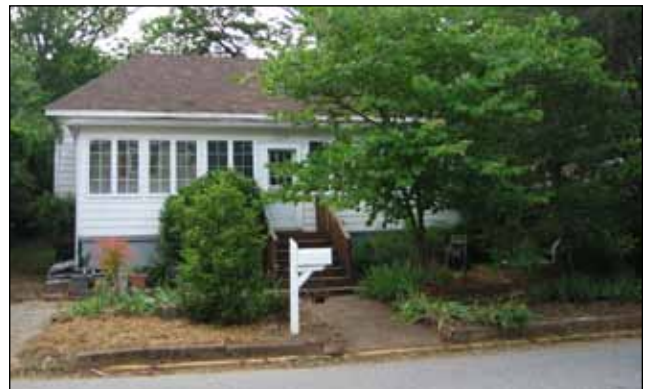
**253 Satula Ave. / Tax parcel # 11-4-C4-C010**

**Contributing**

- › c. 1918
- › Hip-roofed Bungalow house type
- › This building was constructed within the period of significance for the district and retains historic integrity. Therefore, it is a contributing resource.
- › Alterations include an enclosed front verandah and nonhistoric shed.

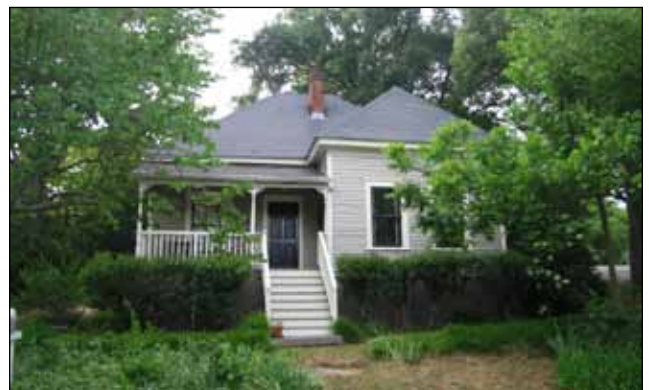
**273 Satula Ave. / Tax parcel # 11-4-C4-C011**

**Contributing**

- › c. 1915
- › Queen Anne cottage house type
- › This building was constructed within the period of significance for the district and retains historic integrity. Therefore, it is a contributing resource.
- › Alterations include porch detailing.

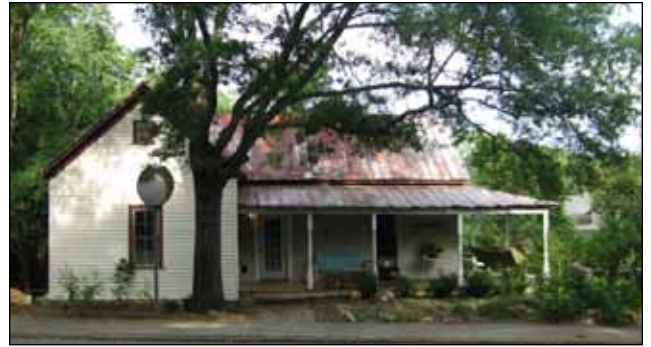
### **320 Satula Ave. / Tax parcel # 11-4-D3-G014**

#### **Contributing**

- › c. 1910
- › Gabled ell cottage house type
- › This building was constructed within the period of significance for the district and retains historic integrity. Therefore, it is a contributing resource.
- › Alterations include rear addition.

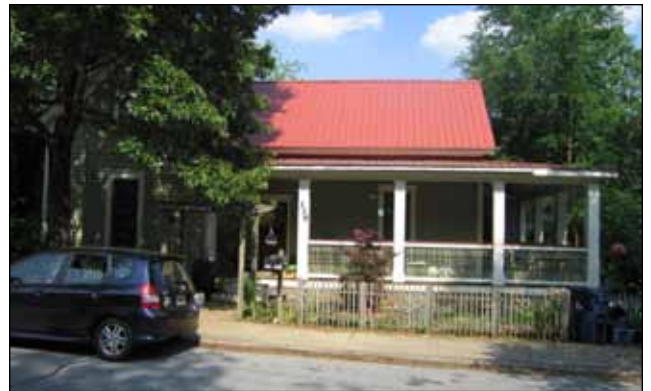
### **338 Satula Ave. / Tax parcel # 11-4-D3-G013**

#### **Contributing**

- › c. 1910
- › Gabled ell cottage house type
- › This building was constructed within the period of significance for the district and retains historic integrity. Therefore, it is a contributing resource.
- › Alterations include rear addition, extended porch and replacement porch supports.
- › There is a noncontributing accessory structure in the backyard.

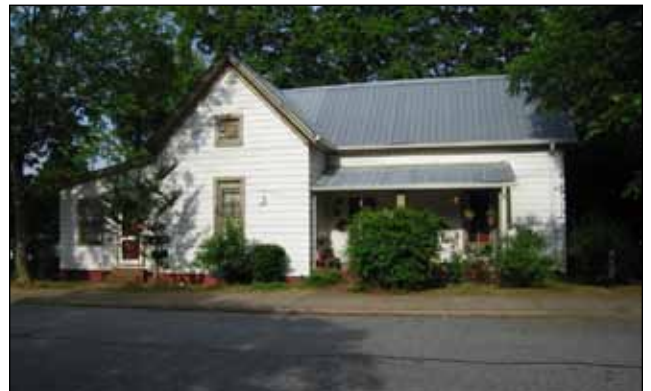
## SATULA AVENUE — 400 BLOCK

- › c. 1910
- › Gabled ell cottage house type
- › This building was constructed within the period of significance for the district and retains historic integrity. Therefore, it is a contributing resource.
- › Alterations include side addition for duplex and multiple rear additions.

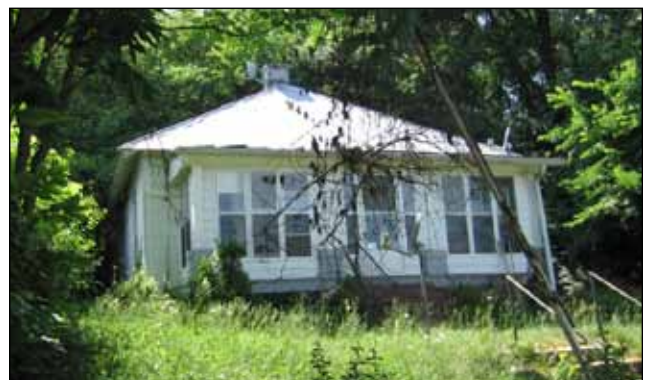
### **491 Satula Ave. / Tax parcel # 11-4-C2-G002**

#### **Contributing**

- › c. 1925
- › Pyramid cottage house type
- › This building was constructed within the period of significance for the district and retains historic integrity. Therefore, it is a contributing resource.
- › Alterations include enclosed front verandah and rear shed addition.

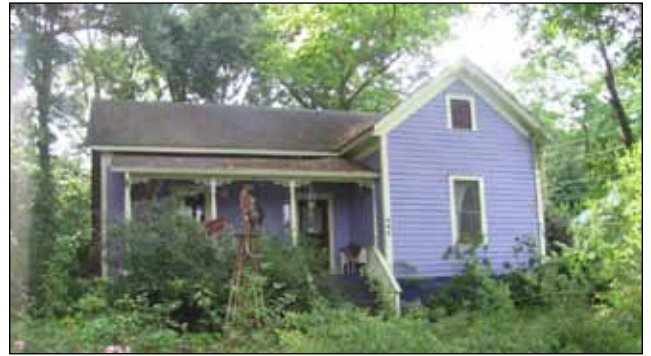
**Contributing**

- › c. 1910
- › Gabled ell cottage house type
- › This building was constructed within the period of significance for the district and retains historic integrity. Therefore, it is a contributing resource.
- › Alterations include porch detailing.

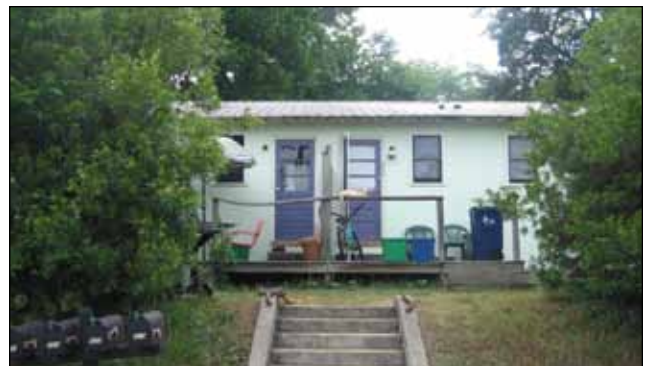
**515/525 Satula Ave. / Tax parcel # 11-4-C2-H005**

**Noncontributing**

- › c. 1975
- › Unknown/duplex apartment
- › This building was constructed after the period of significance for the district. Therefore, it is not a contributing resource.

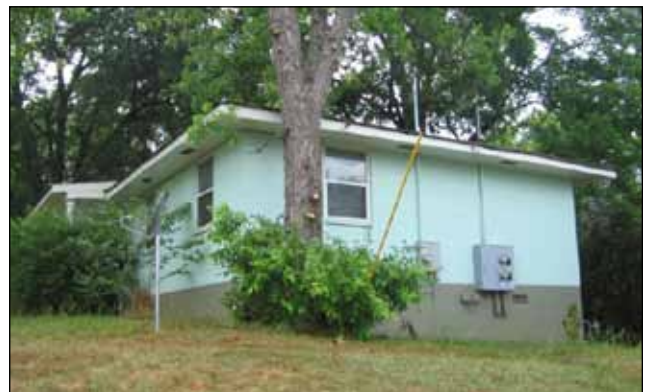
**535/545 Satula Ave. / Tax parcel # 11-4-D3-H005**

**Noncontributing**

- › c. 1975
- › Unknown/duplex apartment
- › This building was constructed after the period of significance for the district. Therefore, it is not a contributing resource.

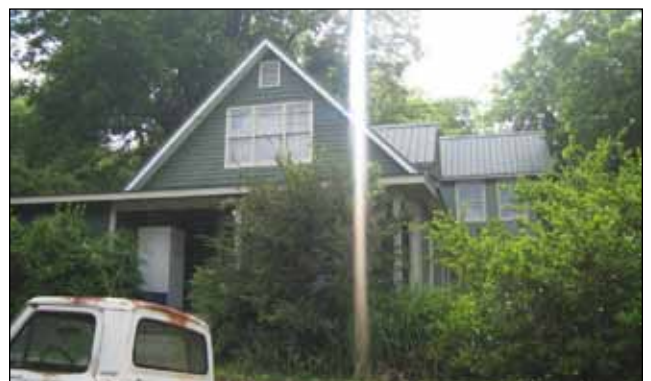
PARK AVENUE — 100 BLOCK

- › c. 1934
- › Cross-gable bungalow house type
- › Although this building was originally constructed within the period of significance for the district, significant alterations have been made to the structure. Therefore, it is not a contributing resource.
- › Alterations include second floor addition, side gable addition, porch additions and enclosures, window replacements and extensive renovations to separate garage behind house.

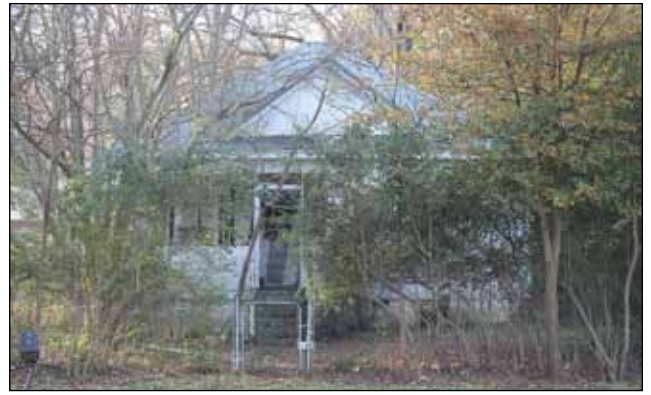
**Contributing**

- › c. 1910
- › Hip-roof bungalow house type
- › This building was constructed within the period of significance for the district and retains its historic integrity. Therefore, it is a contributing resource.
- › Alterations include partially enclosed front verandah and midcentury siding.

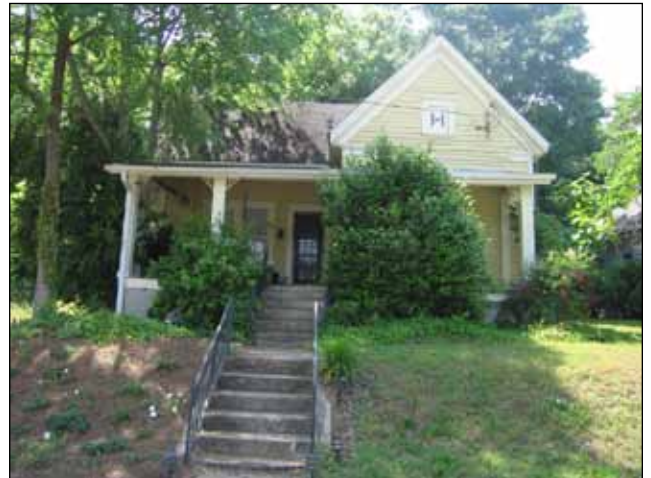
**Contributing**

- › c. 1910
- › Gabled ell cottage house type
- › This building was constructed within the period of significance for the district and retains historic integrity. Therefore, it is a contributing resource.
- › This home includes a nonhistoric rear shed.

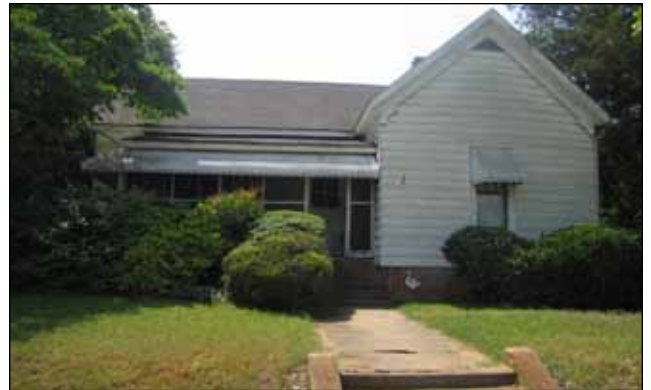
**179 Park Ave. / Tax parcel # 11-4-D3-G004**

**Contributing**

- › c. 1910
- › Gabled ell cottage house type
- › This building was constructed within the period of significance for the district and retains historic integrity. Therefore, it is a contributing resource.
- › Alterations include mid-century aluminum awnings and siding, an enclosed front verandah and a nonhistoric rear shed addition.
- › There is a noncontributing carport in the backyard.

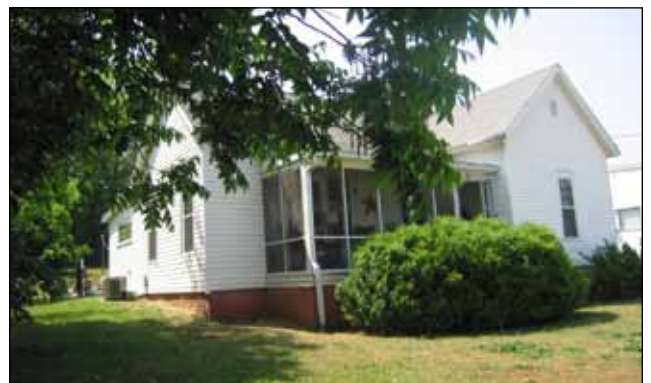
**185 Park Ave. / Tax parcel # 11-4-D3-G005**

**Contributing**

- › c. 1895
- › Gabled ell cottage house type
- › This building was constructed within the period of significance for the district and retains historic integrity. Therefore, it is a contributing resource.
- › Alterations include aluminum siding and a nonhistoric rear shed addition and accessory garage.

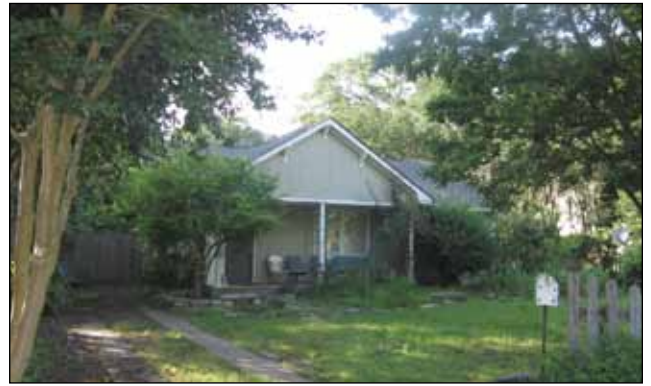
**145 Buena Vista Ave. / Tax parcel # 11-4-C4-A002**

**Contributing**

- › c. 1941
- › Cross gable house type
- › This building was constructed within the period of significance for the district and retains historic integrity. Therefore, it is a contributing resource.
- › Alterations include replacement windows and a porch addition.

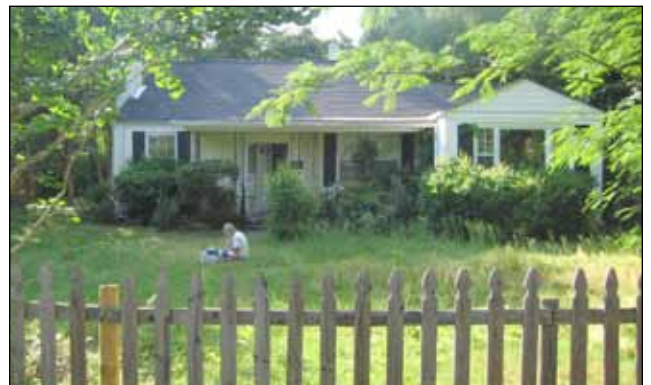
**175 Buena Vista Ave. / Tax parcel # 11-4-C4-A004**

- › c. 1948
- › Ranch house type
- › This building was constructed within the period of significance for the district and retains some historic integrity. Therefore, it is a contributing resource.
- › Alterations include replacement windows, siding and prominent front addition.

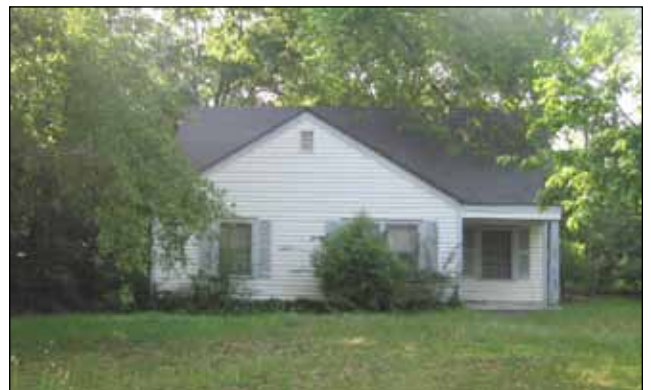
**Contributing**

- › c. 1948
- › Cross gable house type
- › This building was constructed within the period of significance for the district and retains historic integrity. Therefore, it is a contributing resource.
- › Alterations include roof vent replacements and replacement windows and siding.

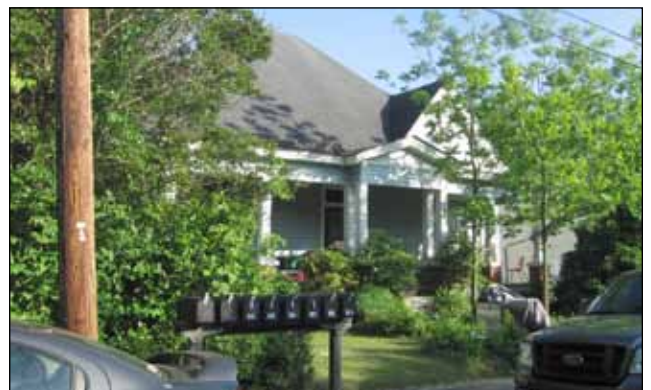
**150 Buena Vista Ave. / Tax parcel # 11-4-C4-B012**

**Contributing**

- › c. 1900
- › Queen Anne cottage house type
- › This building was constructed within the period of significance for the district and retains historic integrity. Therefore, it is a contributing resource.
- › Alterations include additional outbuildings and window replacements.

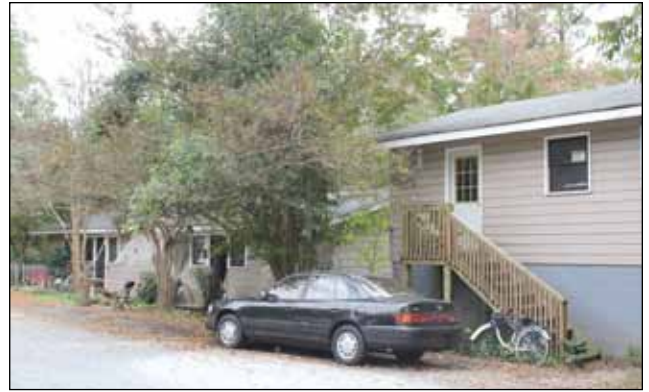
- › Rear apartments were converted from historic garages (c. 1940) but due to renovations, siding/window replacements and other alterations, do not retain their historic character and therefore are not contributing.

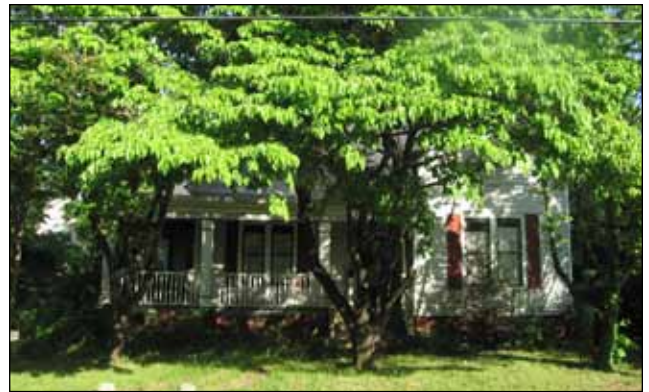
**Contributing**

- › c. 1914
- › Queen Anne cottage house type
- › This building was constructed within the period of significance for the district and retains historic integrity. Therefore, it is a contributing resource.
- › Alterations include a rear addition and replacement doors and windows.

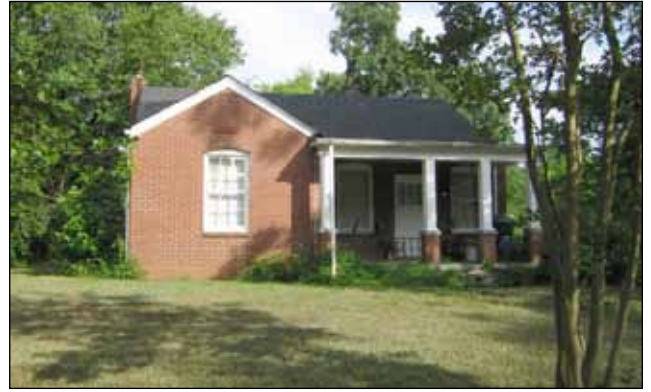
**224 Buena Vista Ave. / Tax parcel # 11-4-C4-C005**

- › c. 1926
- › Gabled ell cottage house type
- › This building was constructed within the period of significance for the district and retains historic integrity, and therefore is a contributing resource.
- › Alterations include a replacement front door.

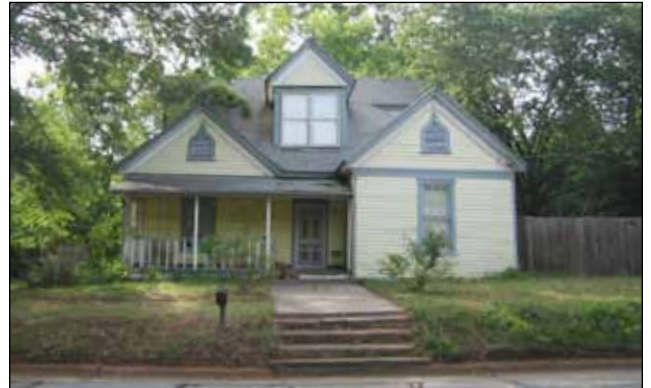
**225 Buena Vista Ave. / Tax parcel # 11-4-C2-E002**

- › c. 1910
- › Queen Anne cottage house type
- › This building was constructed within the period of significance for the district and retains historic integrity, and therefore is a contributing resource.
- › Alterations include a large rear addition and replacement window in dormer.
- › There is a noncontributing accessory structure in the backyard.

**Queen Anne cottage:** This house type is characterized by a square main mass with projecting gables on the front and side. The rooms are arranged asymmetrically, and there is no central hallway. The roof is either pyramidal or hipped, and chimneys are usually found in the interior. The Queen Anne cottage appears in both urban and rural areas as popular middle-class housing of the 1880s and 1890s. (Example: 225 Buena Vista Ave., Page 19.)

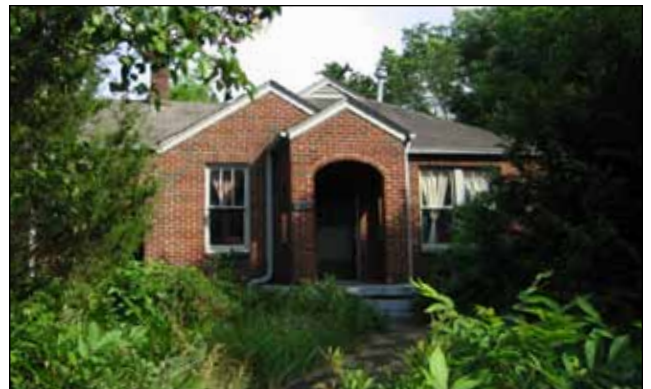
**234 Buena Vista Ave. / Tax parcel # 11-4-C4-C004**

- › c. 1934
- › English cottage house type
- › This building was constructed within the period of significance for the district and retains historic integrity, and therefore is a contributing resource.
- › There is a noncontributing structure in the backyard.

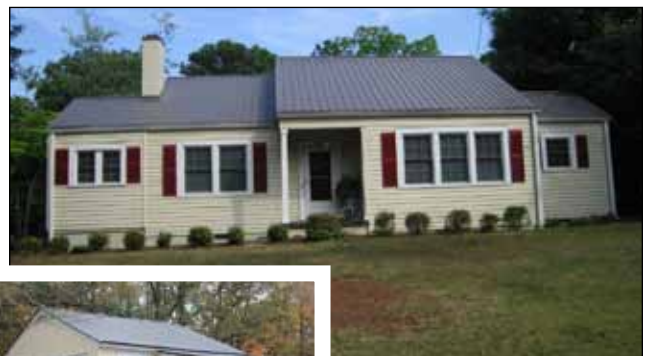
**245 Buena Vista Ave. / Tax parcel # 11-4-C2-E003**

- › c. 1940
- › Ranch house type
- › This building was constructed within the period of significance for the district and retains historic integrity, and therefore is a contributing resource.
- › Alterations include a multiple side and rear additions, replacement windows and vinyl siding.
- › Rear shed is c. 1947 (pictured at right) and is also historic.

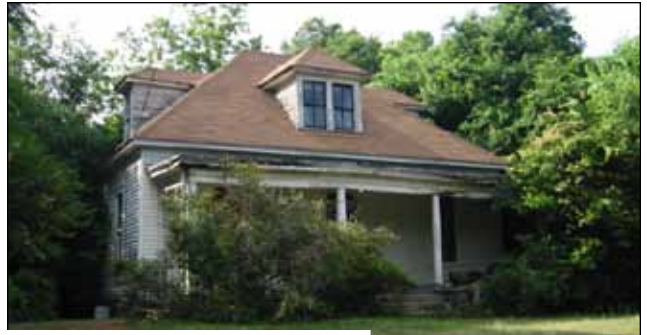
**254 Buena Vista Ave. / Tax parcel #11-4-C4-C002**

- › c. 1915
- › Pyramid cottage house type
- › This building was constructed within the period of significance for the district and retains historic integrity, and therefore is a contributing resource.
- › Alterations include window replacements.
- › Rear structure on property also is historic, once housing the Deep Rock Ginger Ale Company (c. 1910) (photo at right)

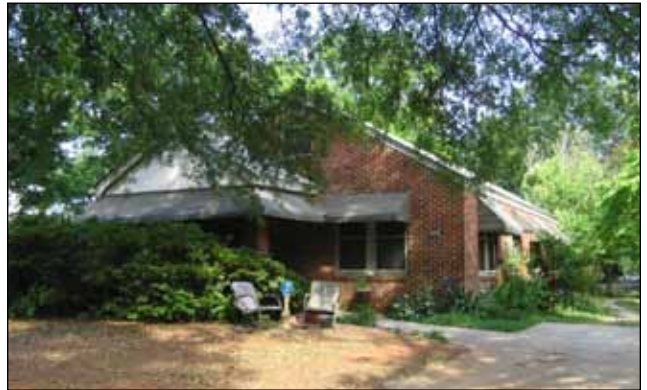
- › c. 1945
- › Cross gable bungalow house type
- › This building was constructed within the period of significance for the district and retains historic integrity, and therefore is a contributing resource.
- › Alterations include mid-century awnings and a rear addition.
- › Accessory structure in backyard is noncontributing.

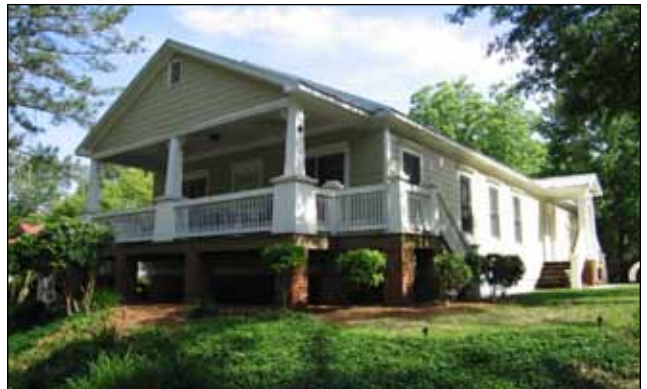
**264 Buena Vista Ave. / Tax parcel # 11-4-C4-C001A**

- › c. 2005
- › This building was constructed after the period of significance for the district and therefore is not a contributing resource.

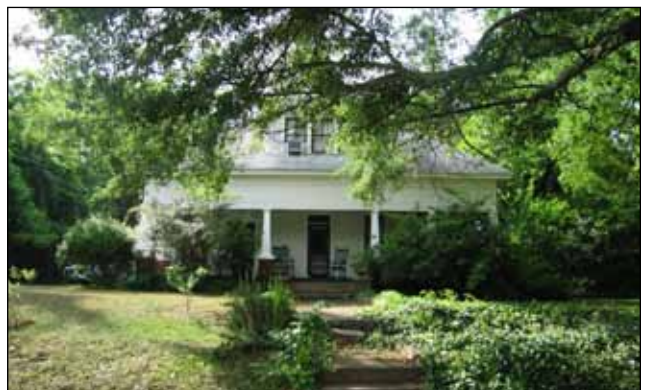
**269 Buena Vista Ave. / Tax parcel # 11-4-C2-E004**

- › c. 1915
- › Queen Anne Cottage house type
- › This building was constructed within the period of significance for the district and retains historic integrity, and therefore is a contributing resource.
- › Alterations include rear additions and outbuildings, including a nonhistoric outbuilding that is noncontributing (c. 1967).

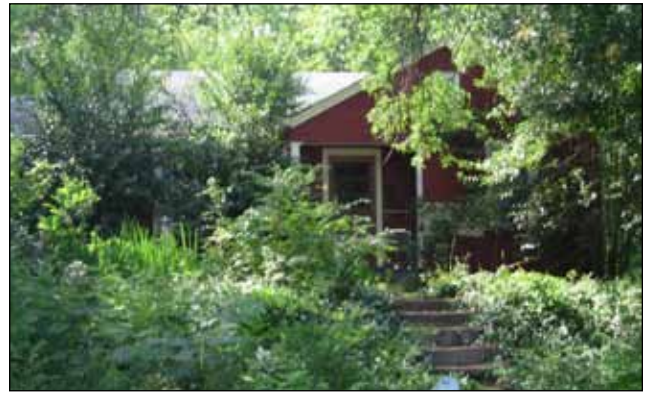
**285 Buena Vista Ave. / Tax parcel # 11-4-C2-E005**

- › c. 1950
- › Cross gable bungalow house type
- › This building was constructed within the period of significance for the district and retains historic integrity, and therefore is a contributing resource.
- › Alterations include a side gable addition.

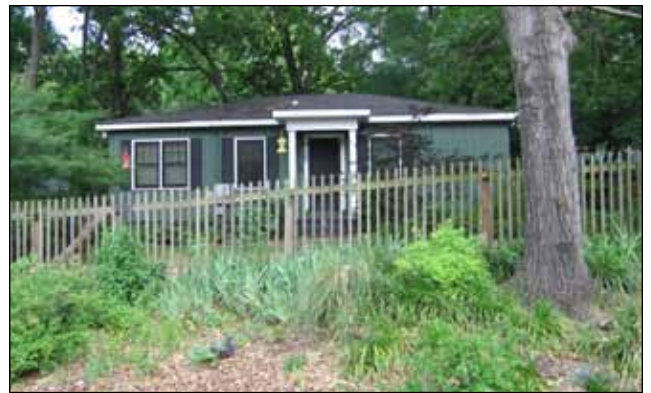
**380 Buena Vista Ave. / Tax parcel # 11-4-C2-G007**

- › c. 1955
- › Ranch house type
- › This building was constructed within the period of significance for the district and retains historic integrity, and therefore is a contributing resource.
- › Alterations include exterior siding, replacement windows and a skylight.
- › There are two noncontributing structures in the side yard.

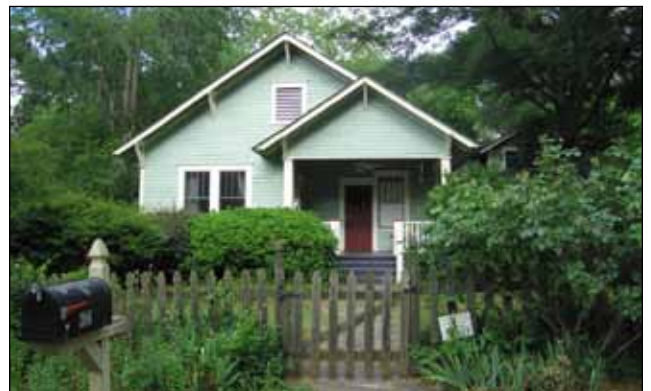
**386 Buena Vista Ave. / Tax parcel # 11-4-C2-G006**

- › c. 1920
- › Front gable bungalow house type
- › This building was constructed within the period of significance for the district and retains historic integrity, and therefore is a contributing resource.
- › Alterations include an attached garage with second-floor living space, replacement siding and windows.

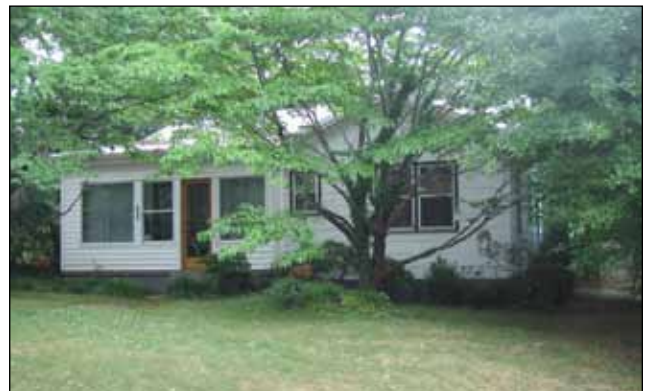
**395 Buena Vista Ave. / Tax parcel # 11-4-C2-F010**

- › c. 1965
- › Cross gable bungalow house type
- › This building was constructed after the period of significance for the district and therefore is not a contributing resource.

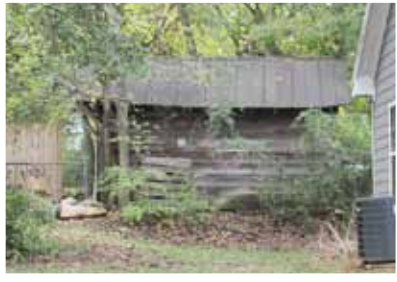
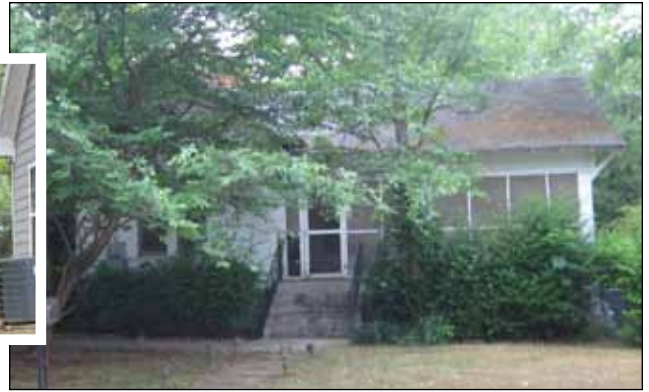
**397 Buena Vista Ave. / Tax parcel # 11-4-C2-F011**

- › c. 1920
- › Gabled ell cottage house type
- › This building was constructed within the period of significance for the district and retains historic integrity, and therefore is a contributing resource.
- › Alterations include an enclosed verandah, aluminum siding and a rear shed addition.
- › Property includes historic shed c. 1920 (inset photo)

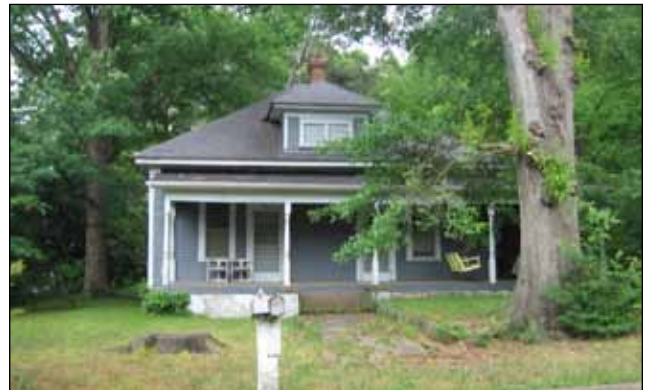
**398 Buena Vista Ave. / Tax parcel # 11-4-C2-G005**

- › c. 1915
- › Pyramid cottage house type
- › This building was constructed within the period of significance for the district and retains historic integrity, and therefore is a contributing resource.
- › Alterations include side and rear shed additions, porch extension and conversion to a duplex.

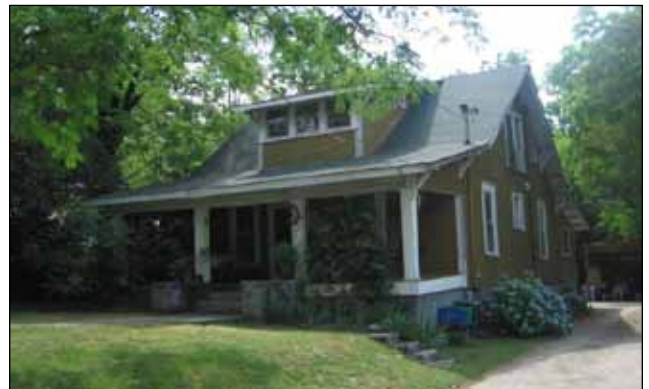
**399 Buena Vista Ave. / Tax parcel # 11-4-C2-F012A**

- › c. 1925
- › Side gable bungalow house type
- › This building was constructed within the period of significance for the district and retains historic integrity, and therefore is a contributing resource.
- › Alterations include replacement windows and rear addition.

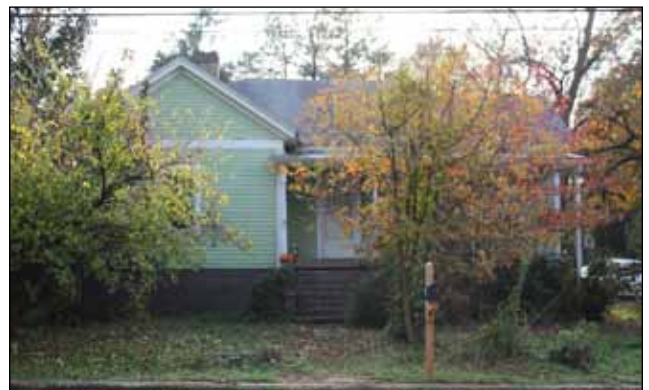
**1393 Boulevard / Tax parcel # 11-4-C2-D006**

- › c. 1915
- › Gabled ell cottage house type
- › This building was constructed within the period of significance for the district and retains historic integrity, and therefore is a contributing resource.
- › Alterations include a rear shed addition (nonhistoric) and changes to the front porch.
- › There is a noncontributing accessory structure in the backyard.

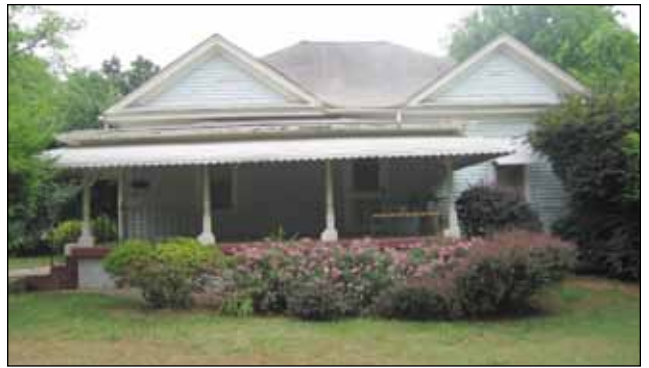
**1387 Boulevard / Tax parcel # 11-4-C2-D005**

- › c. 1910
- › Queen Anne cottage house type
- › This building was constructed within the period of significance for the district and retains historic integrity, and therefore is a contributing resource.
- › Alterations include mid-century awning over windows and porch, plus alterations to porch.
- › The accessory structure in the backyard is noncontributing.

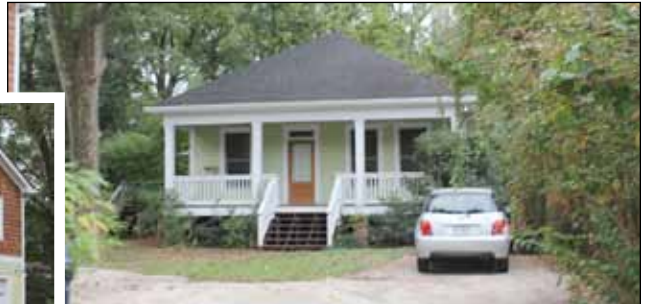
**1377 Boulevard / Tax parcel # 11-4-C2-D003B**

- › c. 2000
- › This building was constructed after the period of significance for the district and therefore is not a contributing resource.
- › Separate garage also not historic and is noncontributing.

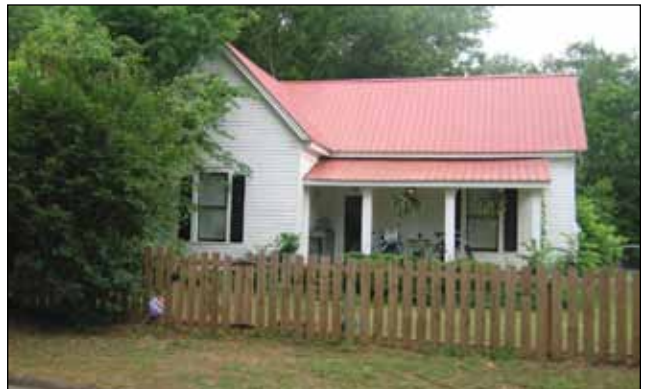
**1295 Boulevard / Tax parcel # 11-4-C2-E008**

- › c. 1903
- › Gabled ell cottage house type
- › This building was constructed within the period of significance for the district and retains historic integrity, and therefore is a contributing resource.
- › Alterations include a large rear addition.

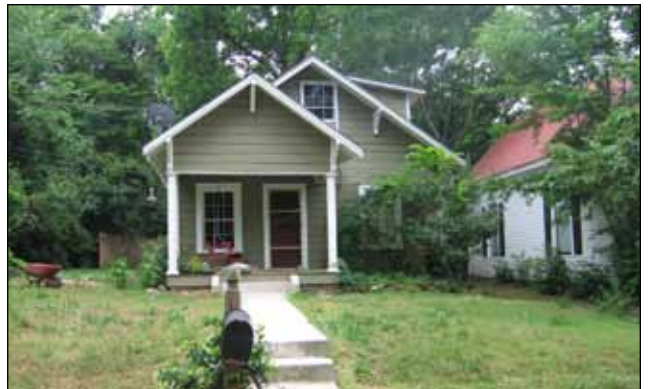
**1285 Boulevard / Tax parcel # 11-4-C2-E007**

- › c. 1923
- › Although this building was constructed before the period of significance for the district, it has had extensive renovations and is therefore not a contributing resource.

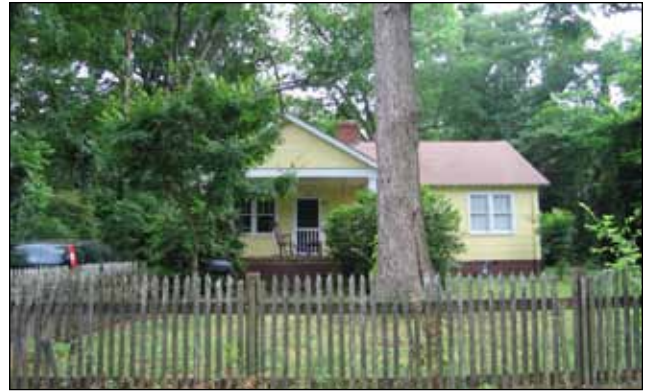
**1233 Boulevard / Tax parcel # 11-4-C2-E006**

- › c. 1949
- › Cross gable bungalow house type
- › This building was constructed within the period of significance for the district and retains historic integrity, and therefore is a contributing resource.
- › Alterations include a nonhistoric shed addition to right side of facade, replacement windows, aluminum siding.
