## LOCAL HISTORIC PROPERTY DESIGNATION REPORT

**historic name** Buena Vista Heights Historic District  
**other names/site number**

**street & number** The Buena Vista Heights Historic District is an area of approximately eight square blocks located west of the Boulevard Historic District in Athens, Georgia.  
The area is roughly bounded by the front property lines of parcels along the western side of Park Avenue and the western side of Satula Avenue (East); the rear property lines of parcels along the northern side of Nantahala Extension and the front property lines of parcels on the southern side of Boulevard (North); the rear property lines of parcels on the western side of Buena Vista Avenue and the front property lines of parcels on the eastern side of Pound Street (West); by the northern rear property lines of properties at the northern side of Prince Avenue (South). For precise boundaries, SEE ATTACHED HISTORIC DISTRICT MAP (Page 6).

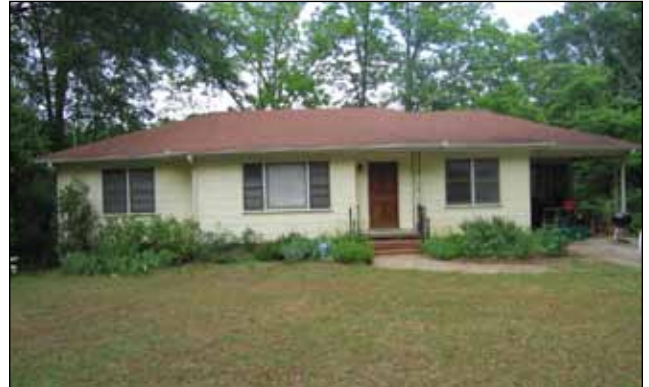
**1220 Boulevard / Tax parcel # 11-4-C2-F009**

- › c. 1955
- › Ranch house type
- › This building was constructed within the period of significance for the district and retains historic integrity, and therefore is a contributing resource.
- › Alterations include a large hipped rear addition.

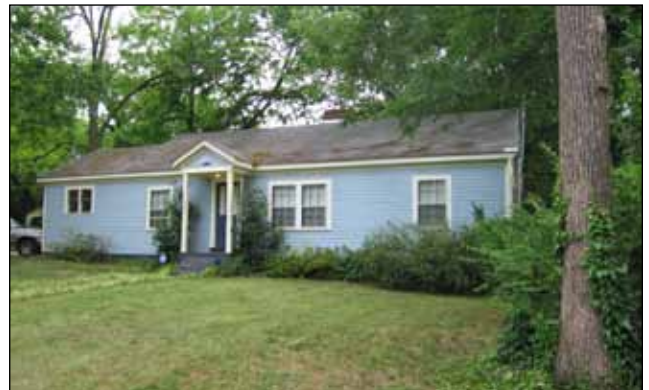
**1225 Boulevard / Tax parcel # 11-4-C2-E005A**

- › c. 1960
- › Ranch house type
- › This building was constructed within the period of significance for the district and retains historic integrity, and therefore is a contributing resource.

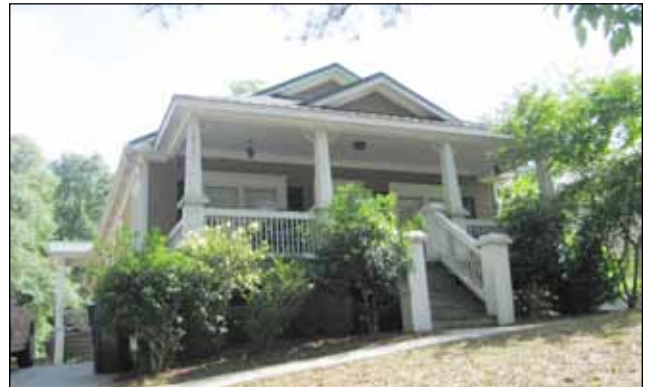
**1185 Boulevard / Tax parcel # 11-4-C4-C001B**

- › c. 2005
- › This building was constructed after the period of significance for the district and therefore is not a contributing resource.

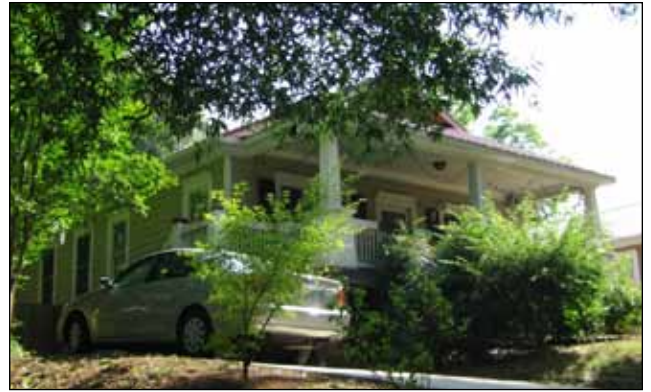
**1175 Boulevard / Tax parcel # 11-4-C4-C001**

- › c. 2005
- › This building was constructed after the period of significance for the district and therefore is not a contributing resource.

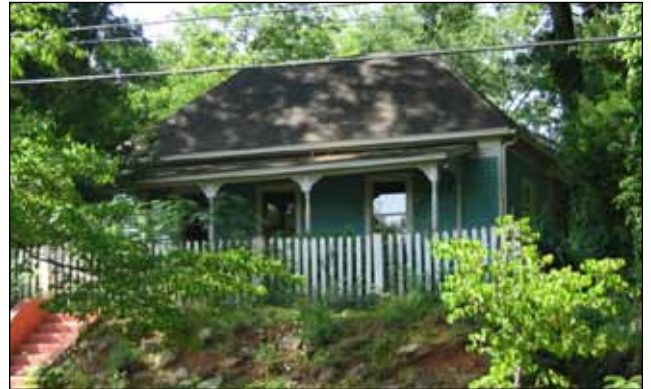
**1160 Boulevard / Tax parcel # 11-4-C2-G008**

- › c. 1910
- › Pyramid cottage house type
- › This building was constructed within the period of significance for the district and retains historic integrity, and therefore is a contributing resource.
- › Alterations include multiple rear additions.

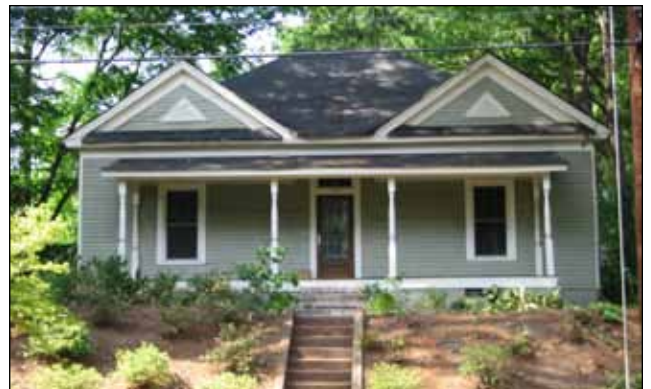
**1150 Boulevard / Tax parcel # 11-4-C2-G009**

- › c. 1915
- › Queen Anne cottage house type
- › This building was constructed within the period of significance for the district and retains historic integrity, and therefore is a contributing resource.
- › Alterations include replacement front door.

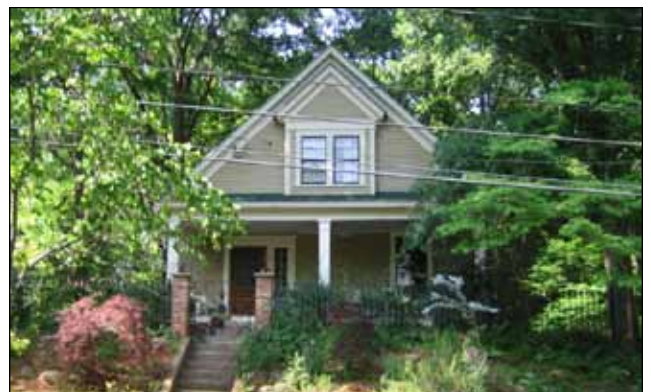
**1140 Boulevard / Tax parcel # 11-4-C2-G010**

- › c. 1915
- › Front gable bungalow house type
- › This building was constructed within the period of significance for the district and retains historic integrity, and therefore is a contributing resource.
- › Alterations include replacement windows and doors, second-floor expansion and large nonhistoric rear shed.

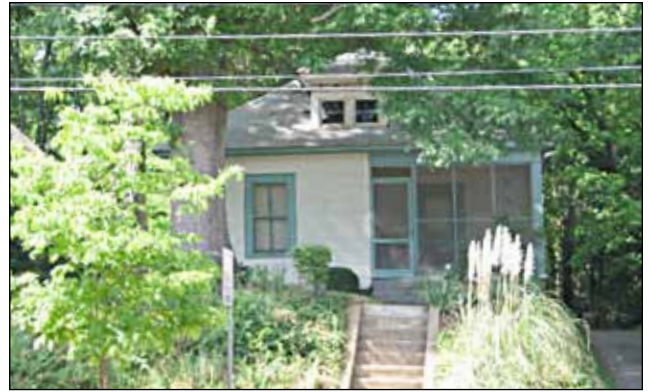
**1130 Boulevard / Tax parcel # 11-4-C2-G011**

- › c. 1915
- › Hip-roof bungalow house type
- › This building was constructed within the period of significance for the district and retains historic integrity, and therefore is a contributing resource.
- › Alterations include large rear shed addition (nonhistoric), aluminum siding and screened-in veranda.
- › There is a noncontributing accessory structure in the backyard.

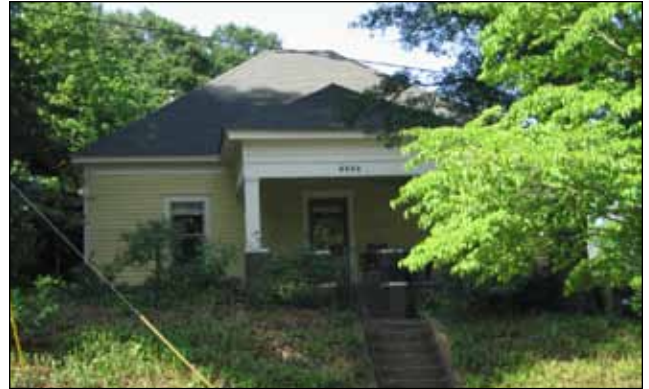
**1120 Boulevard / Tax parcel # 11-4-C2-G001**

- › c. 1915
- › Hip-roof bungalow house type
- › This building was constructed within the period of significance for the district and retains historic integrity, and therefore is a contributing resource.
- › Alterations include a shortened porch from its original full width of the house; rear screened porch, carport and rear bedroom addition; and nonhistoric rear shed.

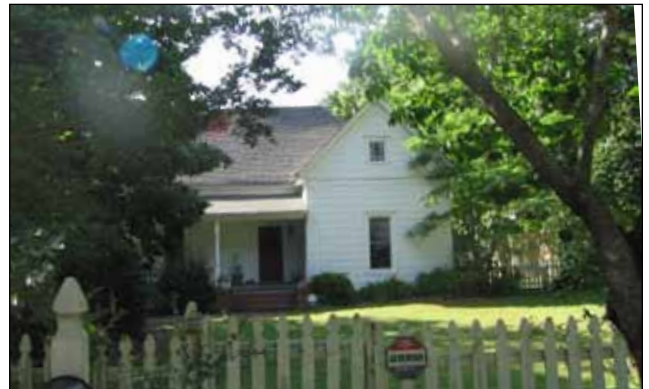
**153 Boulevard Heights / Tax parcel # 11-4-C2-C004**

- › c. 1906
- › Queen Anne cottage house type
- › This building was constructed within the period of significance for the district and retains historic integrity, and therefore is a contributing resource.
- › Alterations include aluminum siding.

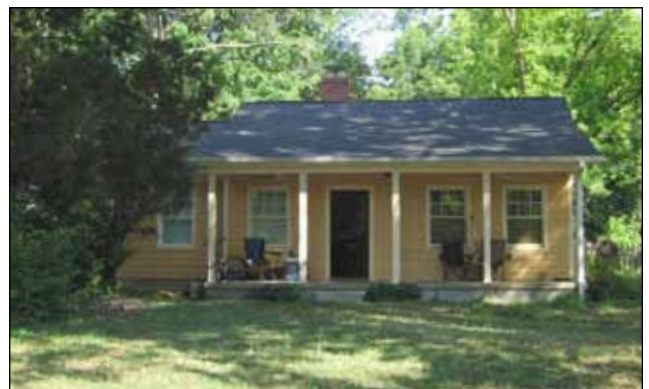
**170 Boulevard Heights / Tax parcel # 11-4-C4-A008**

- › c. 1950
- › Side gable bungalow house type
- › This building was constructed within the period of significance for the district and retains historic integrity, and therefore is a contributing resource.
- › Alternations include replacement windows and doors, side addition.

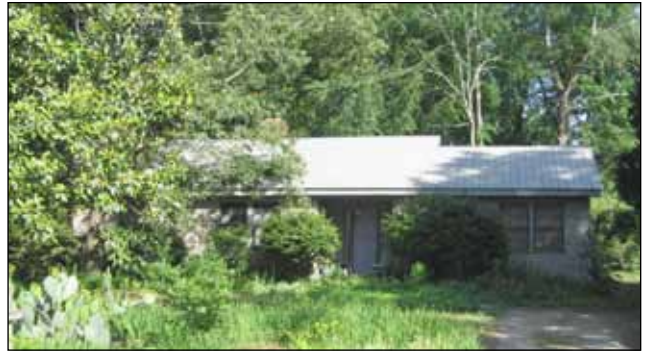
**180 Boulevard Heights / Tax parcel # 11-4-C4-A007**

- › c. 1950
- › Ranch house type
- › This building was constructed within the period of significance for the district and retains historic integrity, and therefore is a contributing resource.
- › Alterations include a significant addition on the right side of the house.

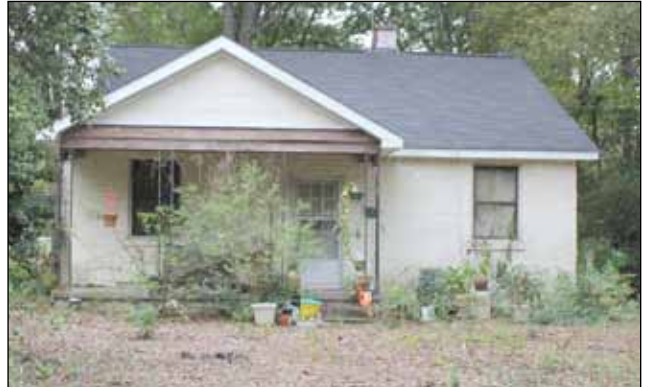
**190 Boulevard Heights / Tax parcel # 11-4-C4-A006**

- › c. 1948
- › Cross gable bungalow house type
- › This building was constructed within the period of significance for the district and retains historic integrity, and therefore is a contributing resource. Alterations include painted brick and iron porch supports.
- › There is an accessory structure in the backyard that is noncontributing.

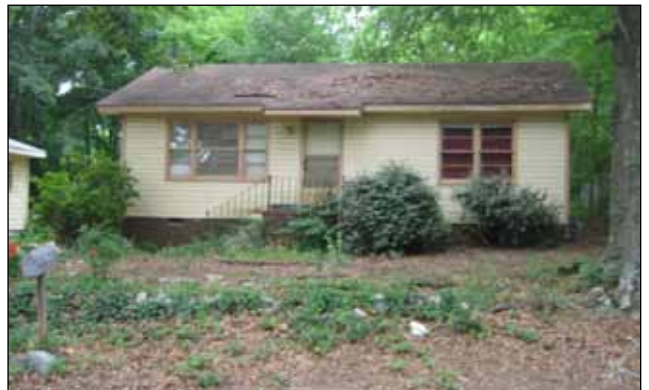
**240 Boulevard Heights / Tax parcel # 11-4-C2-E011**

- › c. 1955
- › Ranch house type
- › This building was constructed within the period of significance for the district and retains historic integrity, and therefore is a contributing resource.
- › There are no significant alterations.

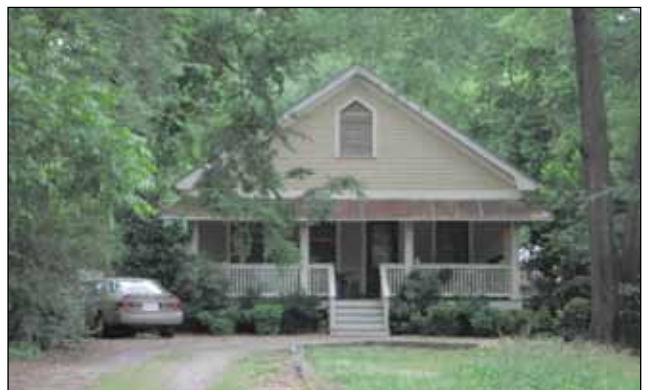
**247 Boulevard Heights / Tax parcel # 11-4-C2-D002A**

- › c. 2002
- › This building was constructed after the period of significance for the district and therefore is not a contributing resource.

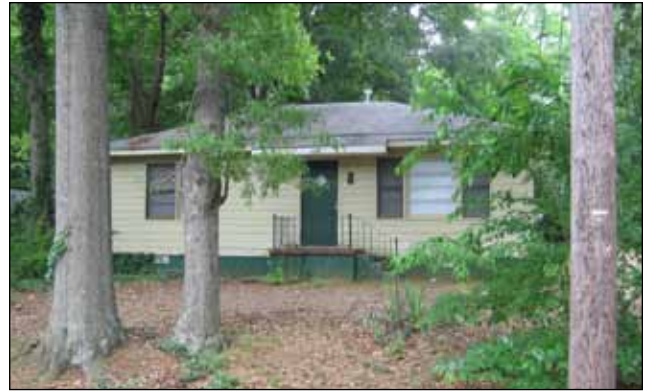
**250 Boulevard Heights / Tax parcel # 11-4-C2-E010**

- › c. 1950
- › Ranch house type
- › This building was constructed within the period of significance for the district and retains historic integrity, and therefore is a contributing resource.
- › There are no significant alterations.

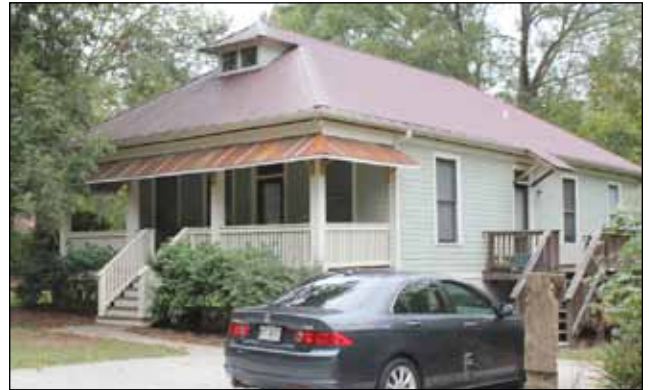
**265 Boulevard Heights / Tax parcel # 11-4-C2-D003**

**Contributing**

- › c. 1914
- › Queen Anne cottage house type
- › This building was constructed within the period of significance for the district and retains historic integrity, and therefore is a contributing resource.
- › Alternations include vents in front gables and large rear addition.

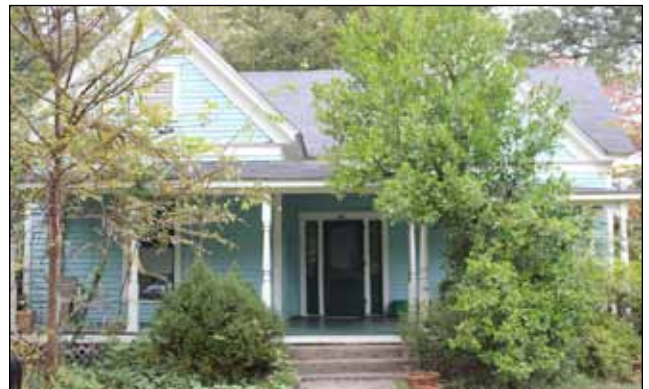
**275 Boulevard Heights / Tax parcel # 11-4-C2-D003A**

**Contributing**

- › c. 1930
- › Front gable (bungalow) house type
- › This building was constructed within the period of significance for the district and retains historic integrity, and therefore is a contributing resource.
- › Alternations include enclosed front verandah and mid-century aluminum awnings on porch.

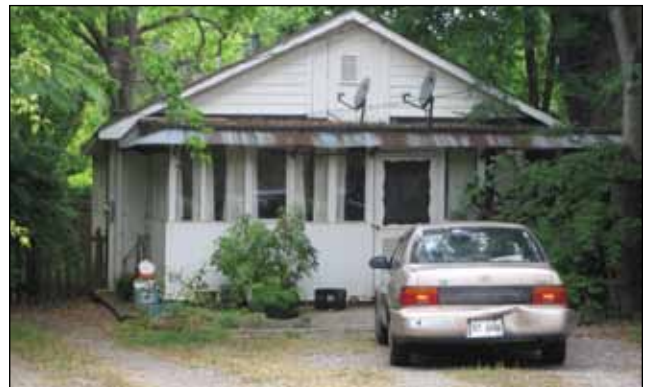
**287 Boulevard Heights / Tax parcel # 11-4-C2-D004**

**Contributing**

- › c. 1909
- › Queen Anne cottage house type
- › This building was constructed within the period of significance for the district and retains historic integrity, and therefore is a contributing resource.
- › Alternations include carriage doors integrated into facade and a large rear addition.

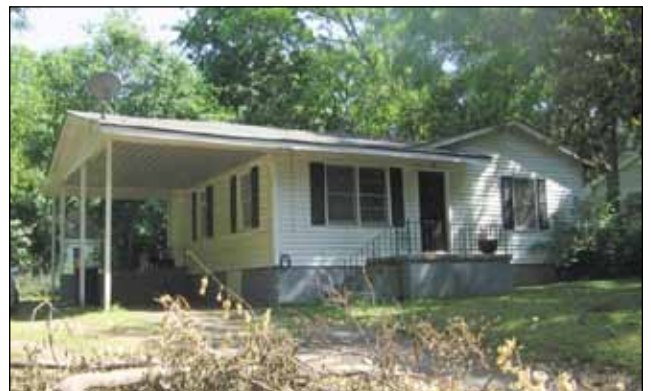
**240 Pound Street / Tax parcel # 11-4-C2-D008**

**Contributing**

- › c. 1960
- › Ranch house type
- › This building was constructed within the period of significance for the district and retains historic integrity, and therefore is a contributing resource.

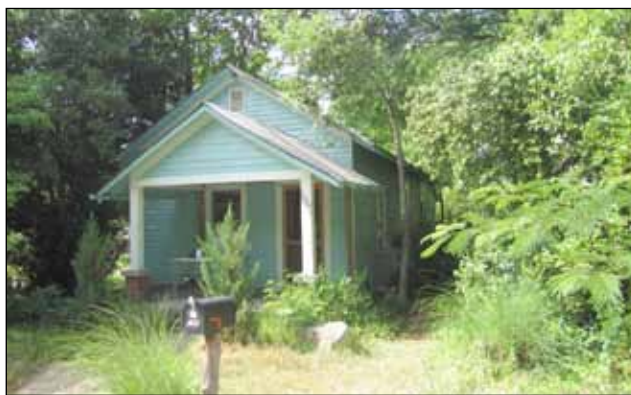
### **170 Nantahala Extension / Tax parcel # 11-4-C2-H002**

- › c. 1914
- › Shotgun house type
- › This building was constructed within the period of significance for the district and retains historic integrity, and therefore is a contributing resource.
- › Alterations include additions to the left of the facade and in the rear of the house; replacement windows.

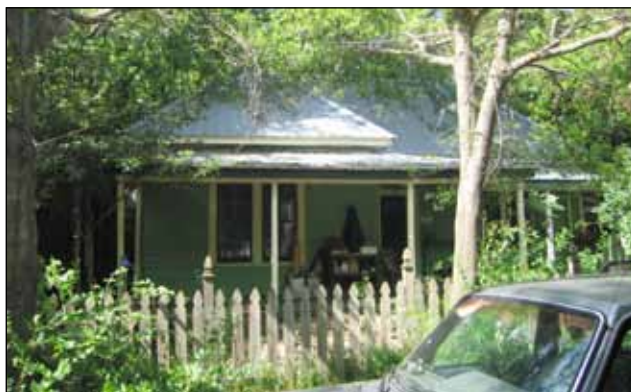
### **167 Nantahala Extension / Tax parcel # 11-4-C2-G004**

#### **Contributing**

- › c. 1925
- › Central hallway house type
- › This building was constructed within the period of significance for the district and retains historic integrity, and therefore is a contributing resource.
- › Alterations included replacement entry door and rear addition; nonhistoric shed.
- › Rear shed is not historic.

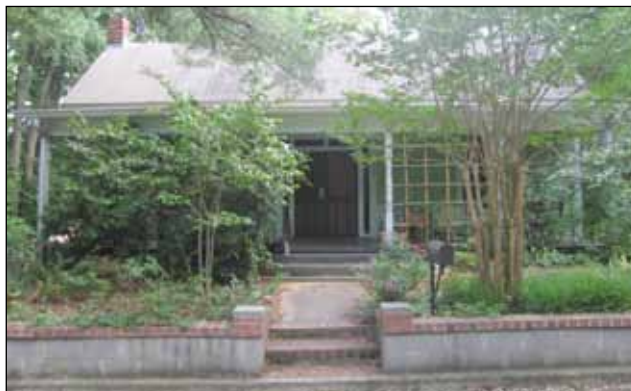
### 158 Nantahala Extension / Tax parcel # 11-4-C2-H003

#### Contributing

- › c. 1914
- › Cross gable bungalow house type
- › This building was constructed within the period of significance for the district and retains historic integrity, and therefore is a contributing resource.
- › Alterations include multiple side additions converting home from its original shotgun house type and porch expansion prior to 1950.
- › There is an accessory structure in the backyard that is noncontributing.

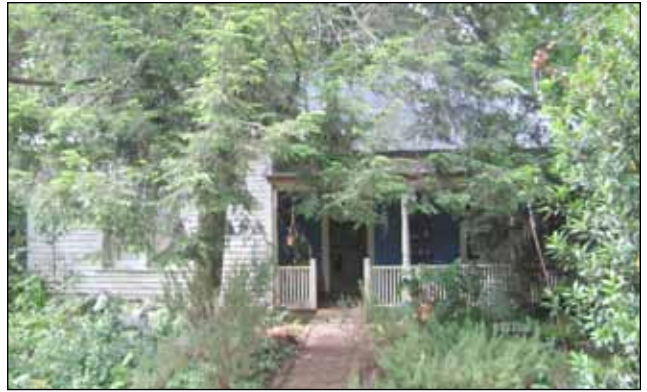
### 140 Nantahala Extension / Tax parcel # 11-4-C2-H004

#### Contributing

- › c. 1914
- › Cross gable bungalow house type
- › This building was constructed within the period of significance for the district and retains its historic integrity, and therefore is a contributing resource.
- › The home was modified prior to 1926 to include left-side addition. A large rear shed addition was later added.
- › Two structure (inset above) is noncontributing.

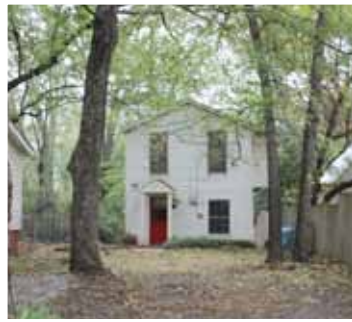
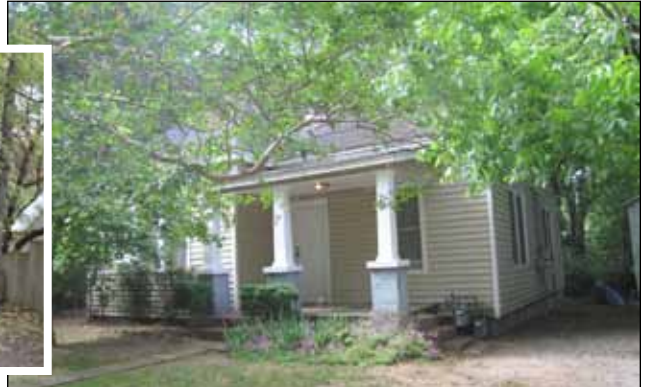
### 128 Nantahala Extension/Tax parcel # 11-4-C2-H005A

#### Contributing

- › c. 1914
- › Shotgun house type
- › This building was constructed within the period of significance for the district and retains historic integrity, and therefore is a contributing resource.
- › Alterations include a rear addition.
- › Historic accessory buildings c. 1918 also contributing.

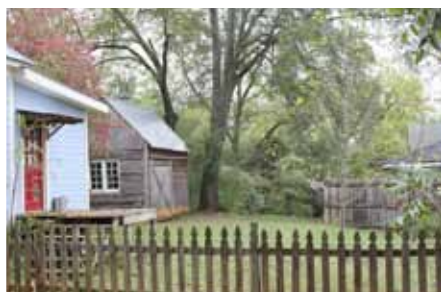
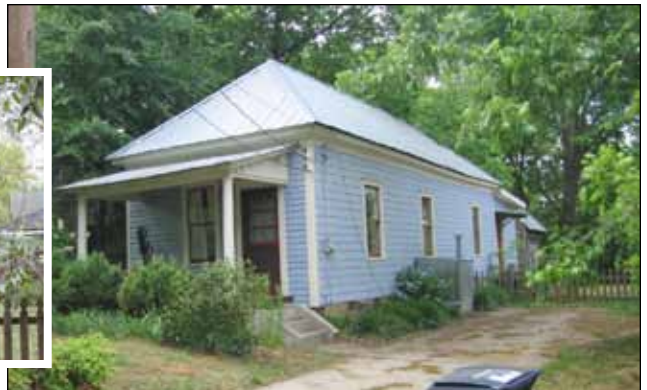
### **130/130 1/2 Easy Street / Tax parcel # 11-4-D3-G018**

#### **Contributing**

- › c. 1920
- › Hip-roofed bungalow house type
- › This building was constructed within the period of significance for the district and retains historic integrity. Therefore, it is a contributing resource.
- › Alterations include a screened veranda.
- › Structure behind main house not original to the site (see inset photo above) and is noncontributing. A second accessory structure (remnants of shed) is noncontributing.

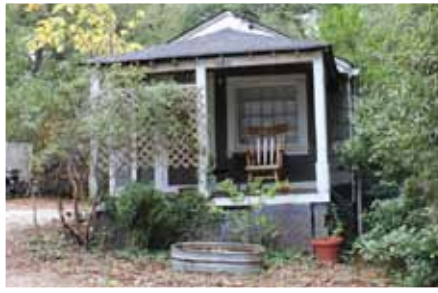
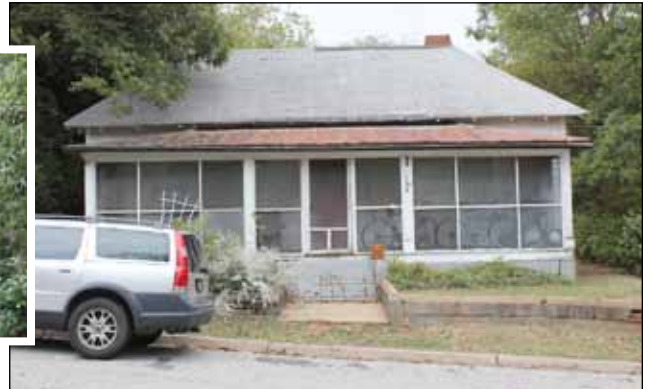
### **136 Easy Street / Tax parcel # 11-4-D3-G019**

#### **Contributing**

- › c. 1945
- › Hip-roofed bungalow house type
- › This building was constructed within the period of significance for the district and retains historic integrity. Therefore, it is a contributing resource.
- › Alterations include replacement windows and enclosed verandah.

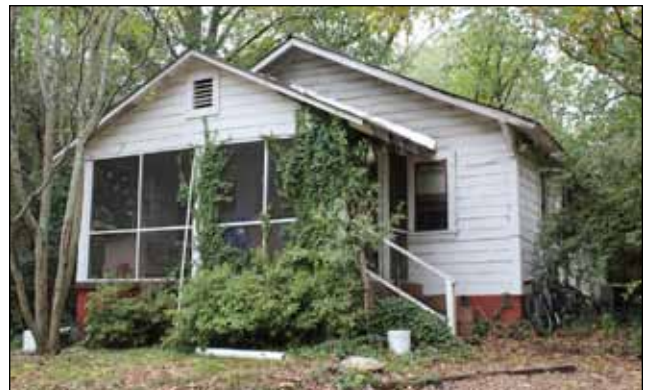
### **140 Easy Street / Tax parcel # 11-4-D3-G017**

#### **Contributing**

- › c. 1945
- › Gabled ell cottage house type
- › This building was constructed within the period of significance for the district and retains historic integrity. Therefore, it is a contributing resource.
- › Alterations include a rear shed addition and screened verandah.

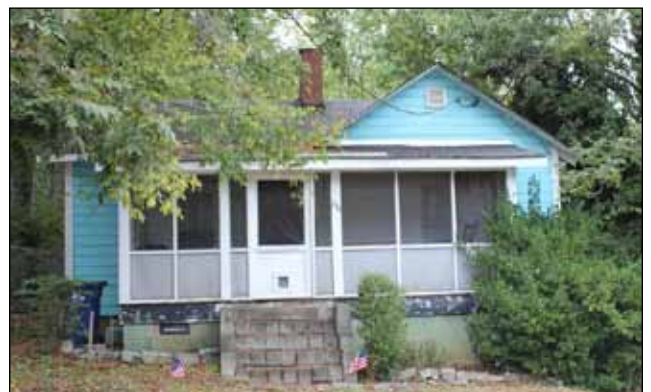
**150 Easy Street / Tax parcel # 11-4-D3-G016**

**Contributing**

- › c. 1915
- › Gabled ell cottage house type
- › This building was constructed within the period of significance for the district and retains historic integrity. Therefore, it is a contributing resource.
- › Alterations include significant changes to entryway, roof and siding; a rear shed addition; replacement windows.

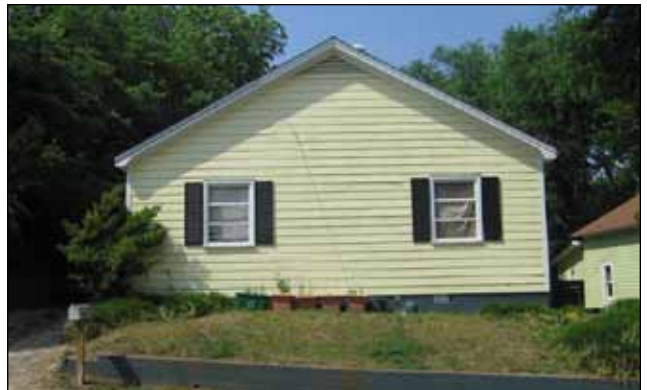
**183 Easy Street / Tax parcel # 11-4-D3-H001**

**Noncontributing**

- › c. 2004
- › This building was constructed after the period of significance for the district and therefore is not a contributing resource.
